Exhibit 8: Palace Theater

Exhibit 8B: Architectural Modifications

Case 1:14-cv-00340-KPF Document 2-8 Filed 01/28/14 Page 6 of 21 **Exh. 8B Architectural Modifications to Palace Theater**

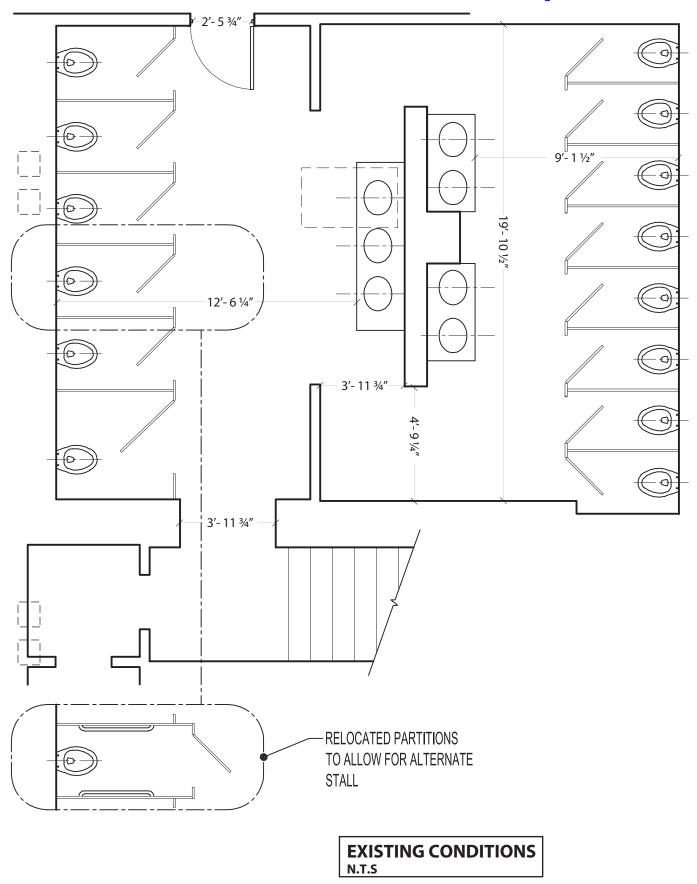
DWG 8A.1

Case 1:14-cv-00340-KPF Document 2-8 Filed 01/28/14 Page 3 of 21 18'- 11 1/2" **EXISTING CONDITIONS** N.T.S 18'- 11 ½" MOVE URINAL TO THE RIGHT RELOCATED APPROX. 3", TO ALLOW FOR **PARTITIONS AND** ACCESSIBLE URINAL CLEAR **NEW SIDE GRAB**

8. PALACE THEATER LOWER LEVEL MEN'S MULTI-USER TOILET ROOM PLAN EXISTING CONDITIONS N.T.S

Line #	Location Description	Existing Condition	Barrier Removal	1991 Standards Reference	Architectural Modification
7	Lower Level (Men's Multi-user Toilet Room)	toilet room. None of the stalls have grab bars or provide any	No accessible stall exists: convert typical stall into standard accessible stall. Modification may require removal of one water closet, if allowed by plumbing code. Install grab bars for standard or alternate accessible stall if standard accessible stall cannot be provided. If standard accessible stall is not provided, install directional sign to accessible toilet.	4.1.3(11) 4.22	Defendant will provide alternate accessible stall and compliant signage to standard accessible toilet.
8	Lower Level (Men's Multi-user Toilet Room)	There are 3 lavatories with base cabinets that obstruct knee clearance.	Modify(y)existing lavatory and counter to provide a compliant counter and lavatory.	4.1.3(11) 4.22.6 4.19.2 Fig. 31	Defendant will provide compliant lavatory.

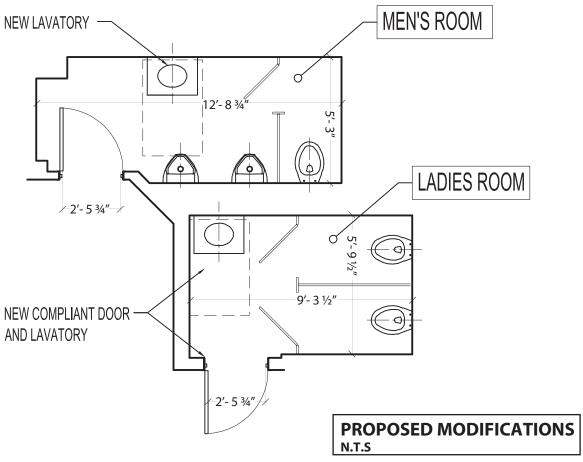
8. PALACE THEATER THIRD LEVEL WOMEN/MEN MULTI-USER TOILET ROOM PLAN

43	Third Level (Men's Multi- user Toilet Room)	The door requires 12 pounds of force to open and travels from 70° open to within 3" of the latch in 2 seconds.	Adjust or replace existing closer to provide compliant speed and force.	4.1.3(7)(c) 4.13.10	Defendant will provide compliant door closer.
44	Third Level (Men's Multi- user Toilet Room)	There are 2 urinals and 1 water closet stall in this toilet room, none are accessible. There is 40" clear from the lavatory to the door swing and 51" clear to the ladder.	No accessible stall exists: convert one typical stall into a compliant standard accessible stall or a 36" wide alternate stall.	4.1.3(11) 4.22 4.16 4.17 Fig. 28 Fig. 30	Defendant will provide a directional sign to an accessible stall in the Lower Level Men Multiuser room.

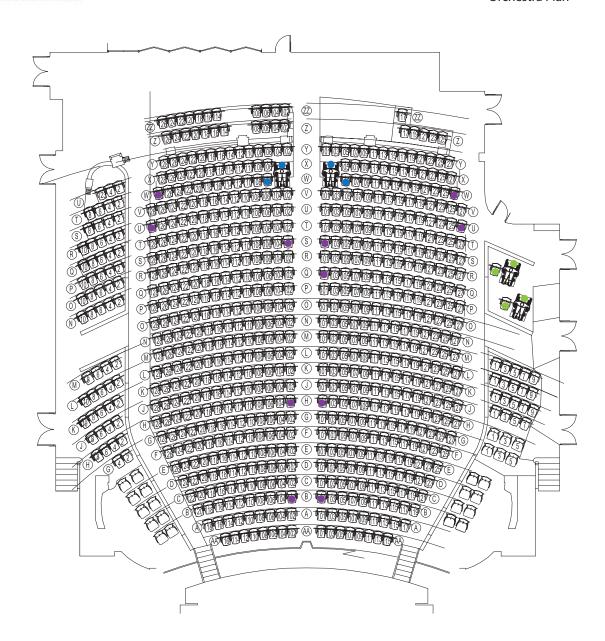
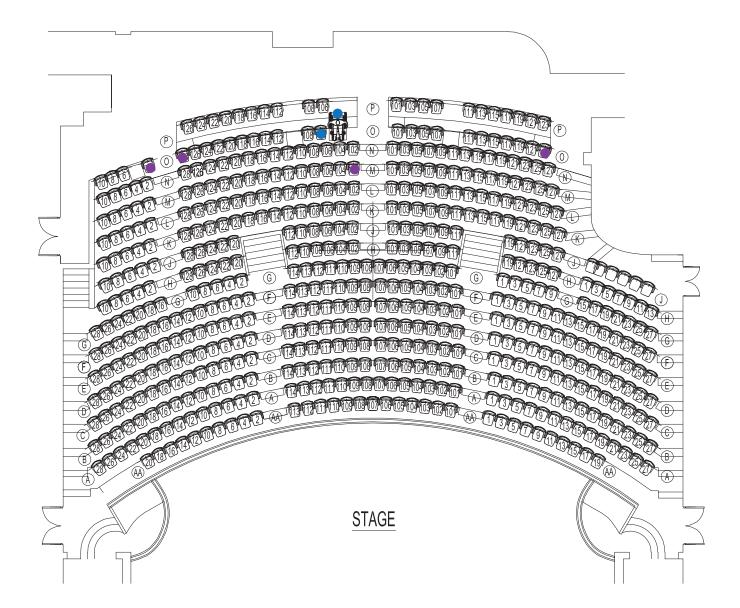
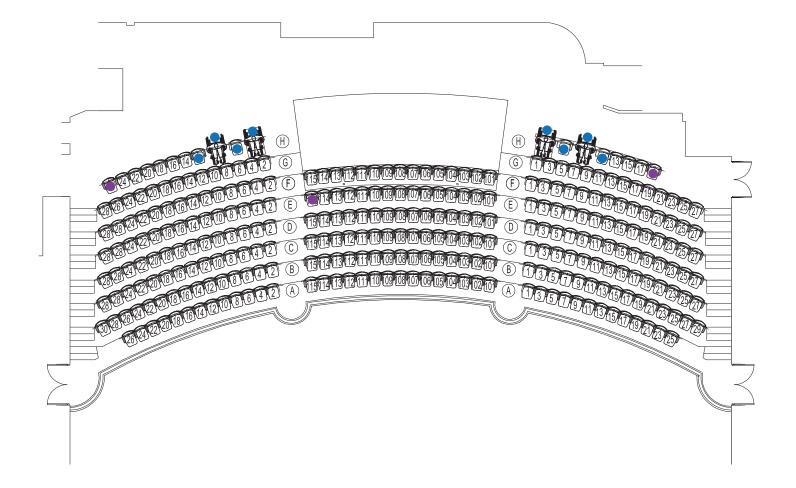
DWG 8C.1

- 1. Nederlander shall maintain the two existing wheelchair and companion seating locations on the Orchestra level, in the area that would be designated Q1/Q3/Q5/R1/R3/R5, and S1/S3/S5/T1/T3/T5, which includes one companion seating location for each wheelchair seating location. Nederlander shall remove the black metal bars to the left of this area.
- 2. Nederlander shall add seven new wheelchair seating locations on the Orchestra level at W101/W103/W105/X101/X103 and at W102/W104/W106/X102/X104; on the Mezzanine level at O102/O104/O106/P102/P104; and on the Balcony at H2/H4/H6; at H8/H10/H12; at H1/H3/H5; and at H7/H9/H11; each of which shall include one companion seating location.

3. Nederlander shall add seventeen new aisle transfer seating locations, eleven on the Orchestra level at B101, B102, H101, H102, Q101, S101, S102, U128, U127, W127, W128; four on the Mezzanine level at M102, O2, O123, and O128; and two on the Balcony level at E115 and H19.
